CENTRE FOR RESEARCH ON INTRODUCED MARINE PESTS

TECHNICAL REPORT NUMBER 1

POTENTIAL FOR THE INTRODUCTION AND TRANSLOCATION OF EXOTIC SPECIES BY HULL FOULING: A PRELIMINARY ASSESSMENT

SEBASTIAN F. RAINER

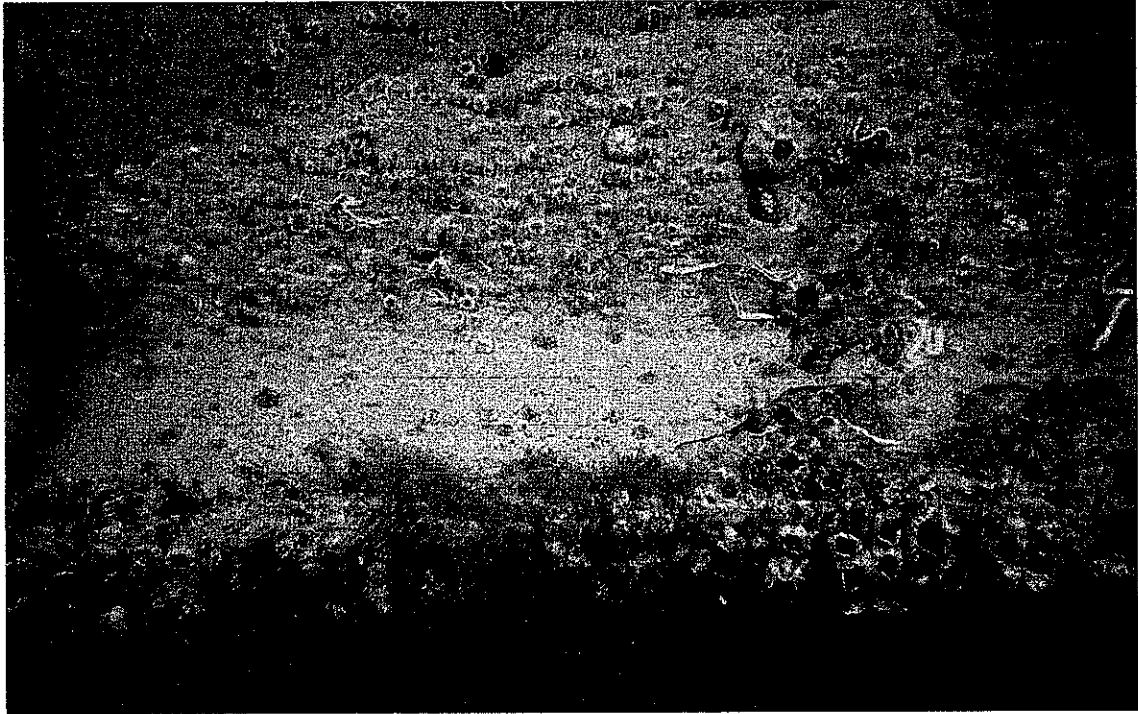
The hull was generally very clean, with only patchy fouling on the bottom and sides, particularly in areas where paint had either been rubbed off or where docking blocks had prevented paint coverage during dockyard anti-fouling. The fouling organisms were typically small balanoid barnacles and bryzoans. On the outer edge and underneath the bilge keels a small horizontal shelf supported larger barnacles, probably a different species, and some hydroids (fig. 1). Towards the stern, fouling became more noticeable with larger barnacles and serpulid worm tubes growing on intake gratings and particularly around the collar of the propeller shaft housing (fig. 2). The propeller itself was clean apart from small balanoid barnacles. Above the water, but below the water-line, we observed some patches of calcareous worm tubes, probably from a serpulid polychaete.

Figure 1. Bilge keel fouling, vessel 1 (frame size 18 x 12.5 cm).

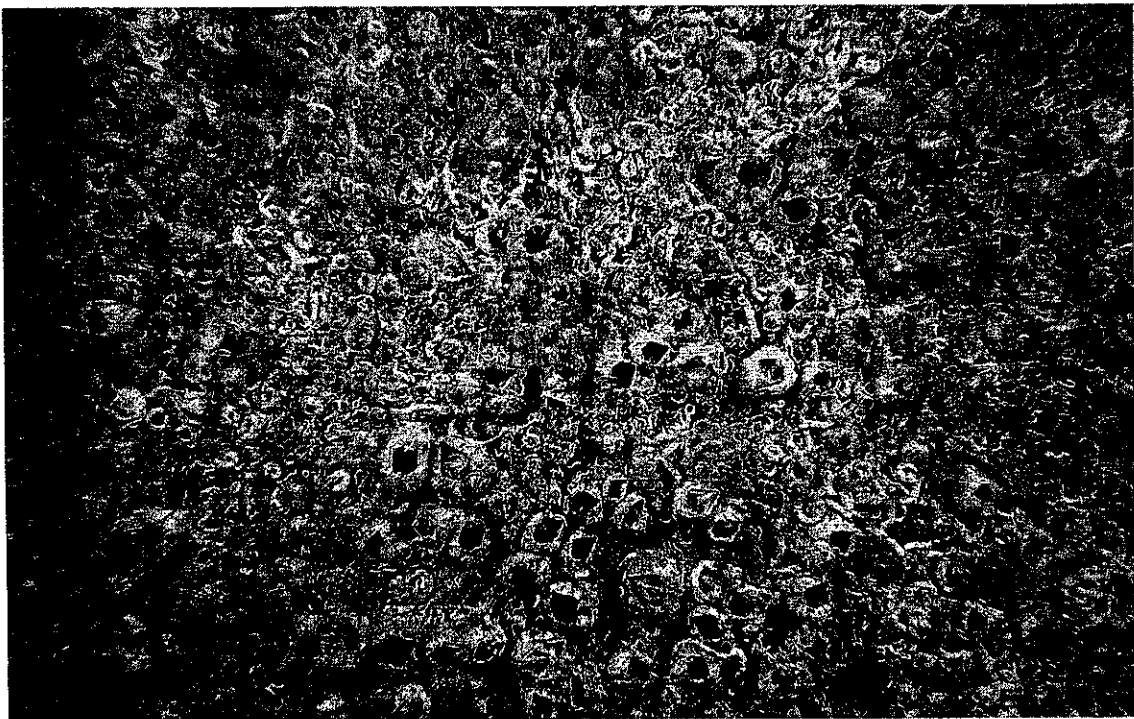
In sheltered places such as recesses associated with the propeller and rudder post, large barnacles were again abundant. Two grated intake vents (one with round holes, one with horizontal bars) near the stern housed a rich assemblage of invertebrates, including at least two species of anemones, more barnacles, a pycnogonid, and dense colonies of hydroids (figs 3 & 4). The square vent was recessed for about half a metre behind the grating and appeared heavily fouled inside.

Figure 2. Propeller collar fouling, vessel 1 (frame size 18 x 12.5 cm).

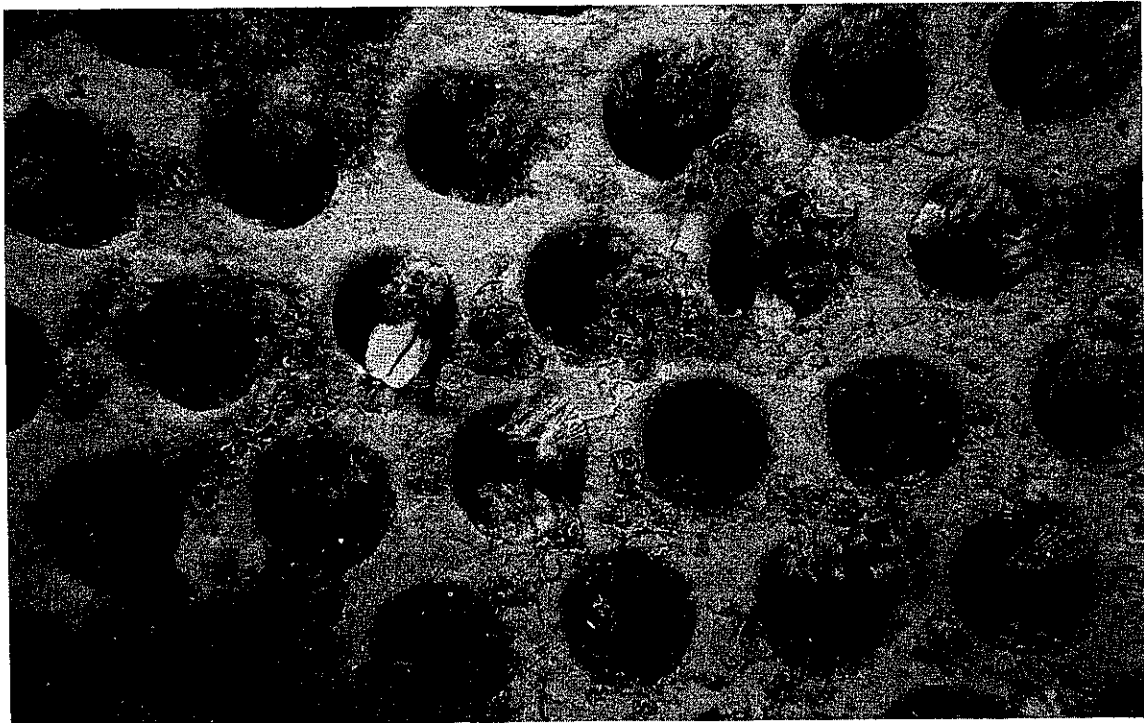
Figure 4. Round intake near stern, vessel 1 (frame size 18 x 12.5 cm).

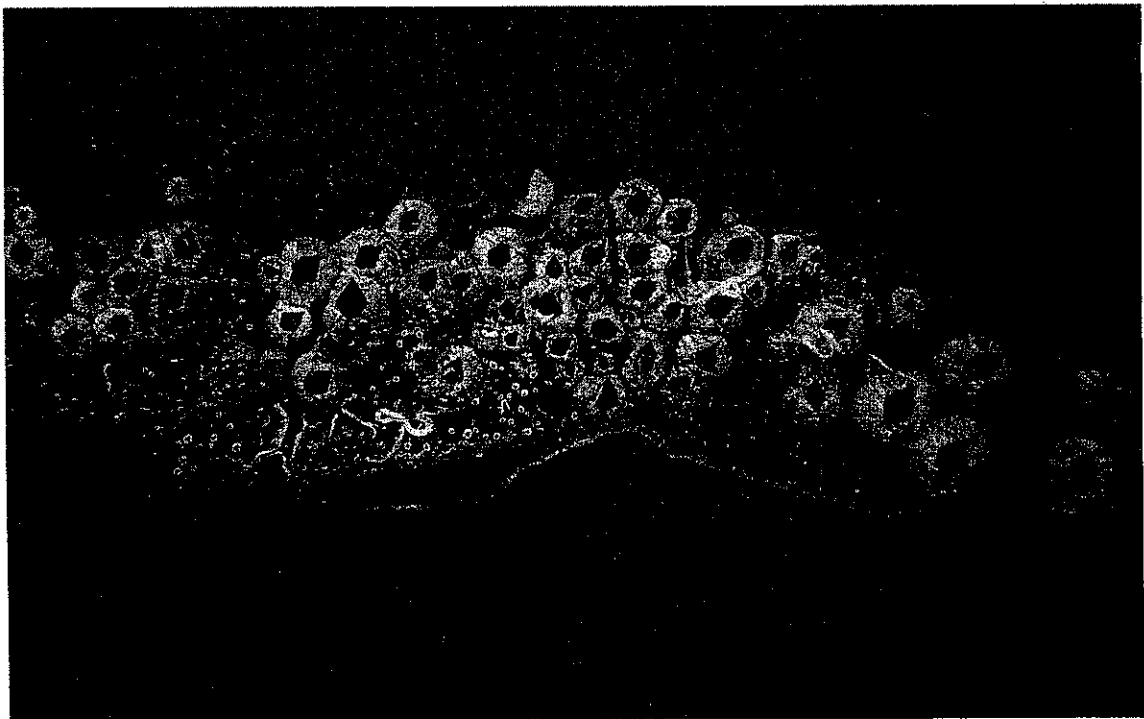
The bottom of the hull was clean except for a few barnacles, mainly where paint was missing (fig. 6). The recessed shelves under the bilge keels were also relatively free of growth. The stern was again more fouled and many large barnacles, up to 5 cm base-width, occurred around the propeller collar (fig. 7) and shaft housing, intake gratings (fig. 8) and in the recesses associated with the rudder, propeller and vent pipes. Most of the large barnacles were dead, but some smaller ones (possibly a different species) were alive. No shrimps or other mobile invertebrates were seen.

Figure 6. Damaged antifouling, hull bottom, vessel 2 (frame size 18 x 12.5 cm).

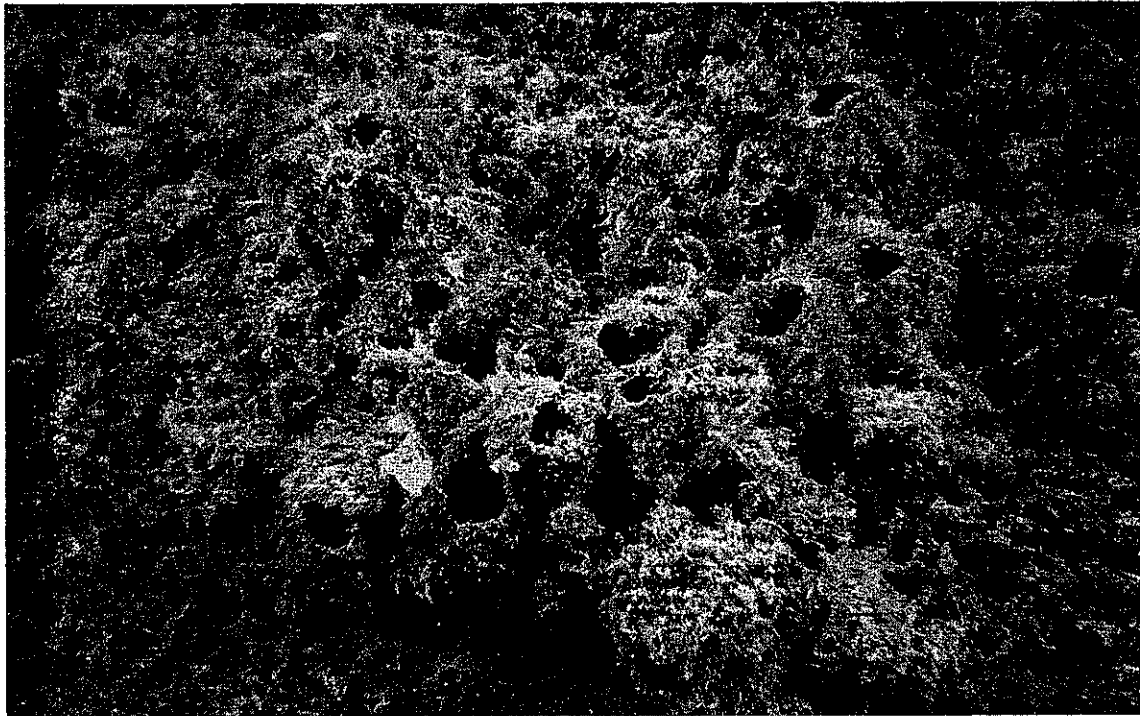
Figure 7. Propeller collar fouling, vessel 2 (frame size 18 x 12.5 cm).
