IN2015\_V02  
ADCP trials and trouble shooting  
May 2015

Susan Wijffels

Summary

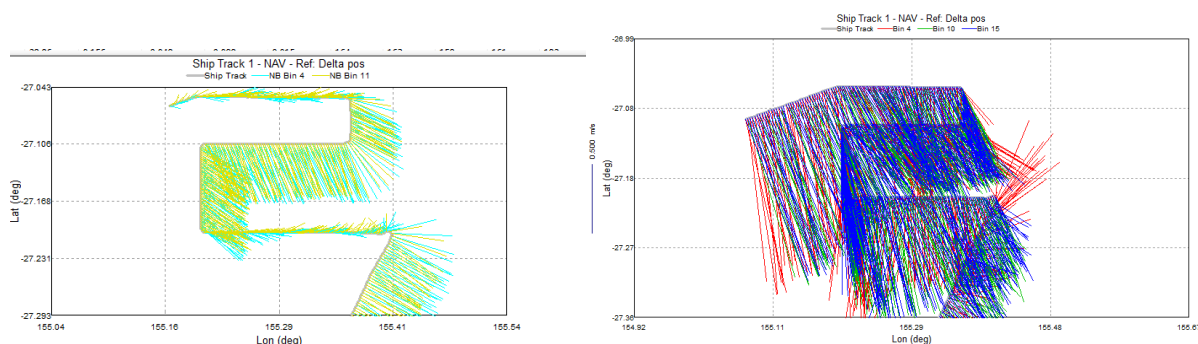
It quickly became apparent that both had alignment problems (stick plots on VMDAS disagreed with each other and the currents changed direction with ship heading changes). See two images below

Figure 1. (left) Track from os75 at ensemble 748 17 May 2015 12:24:22.09 ; (right) Track from os150 at ensemble 781 17 May 2015 12:54:02.00

OS150 EA(new) = 46.29 (old) - 1.94 (new) = 44.35 ( 4435 in config file)

OS75 EA(new) = 45 (old) + 7.43 = 52.44 ( 5244 in config file)

The config files for the two OS were edited to change this, extended the blanking distance on the OS150. The override in VmDAS was disabled.

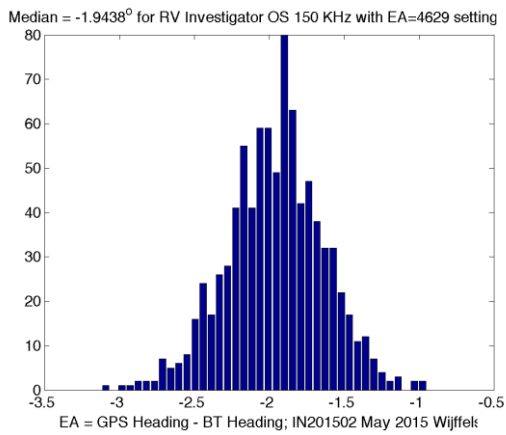
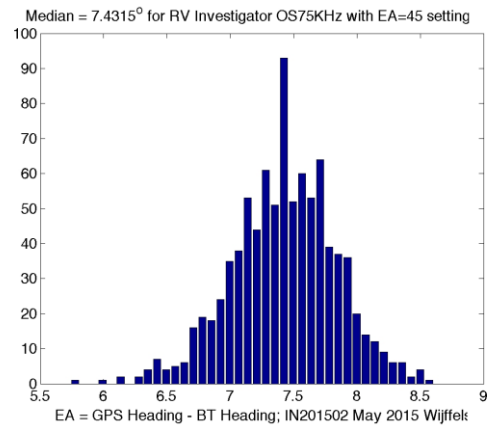
For both ADCPs the values of EA based on the 1 minute STA ensembles were reasonably stable where the bottom track data was good. The median was used as the angle to adjust. See Figure below.

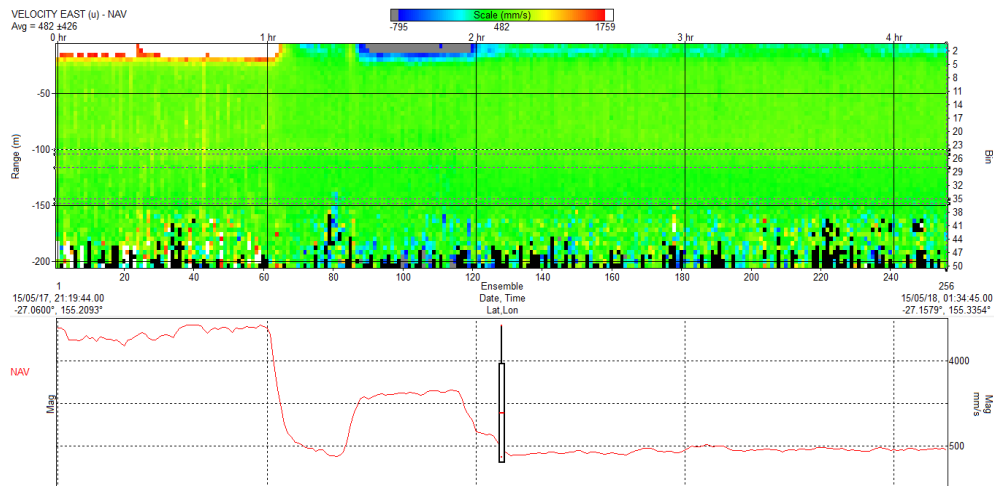
However, after a while we realized that the shear was not always there and would disappear when the ship was not steaming. See examples below from ensemble

Figure 1 – Change in ship speed (bottom) from speed to still showing ADCP surface shear occurring during ship speed at high and mid speed. Intensity of surface shear also decreased with decreased ship speed. No shear while the ship was not moving. Depth of shear was 0 – 5 m.

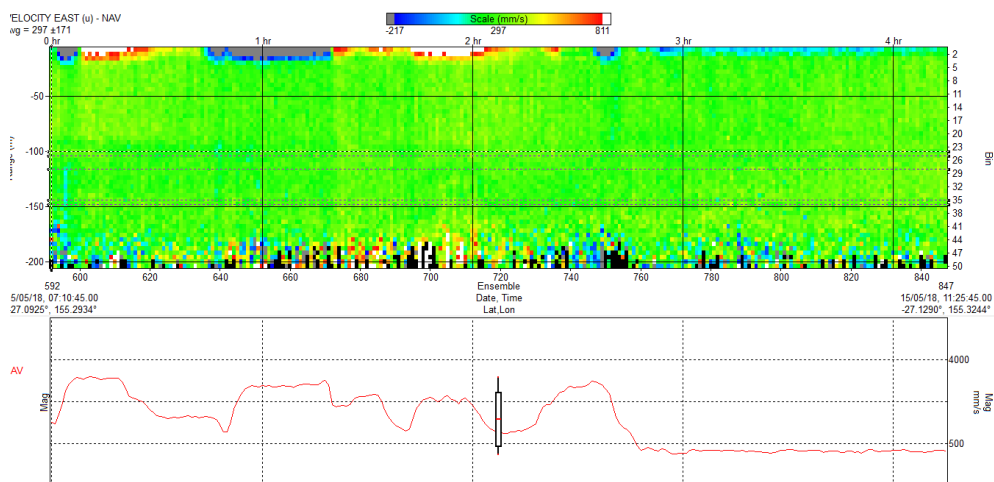
Figure 2 – The high near surface ocean velocities (bubble effect – top panels) was seen to vary with ship speed (red series bottom)

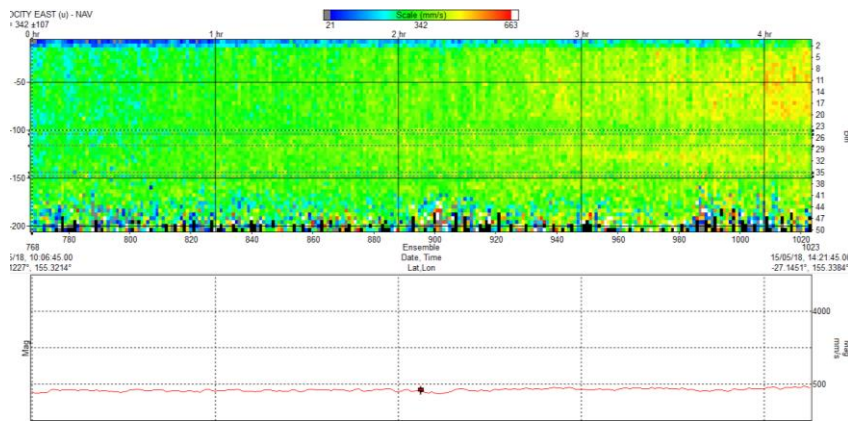
Figure 3 – Bubble effect was seen during constant low ship speed.

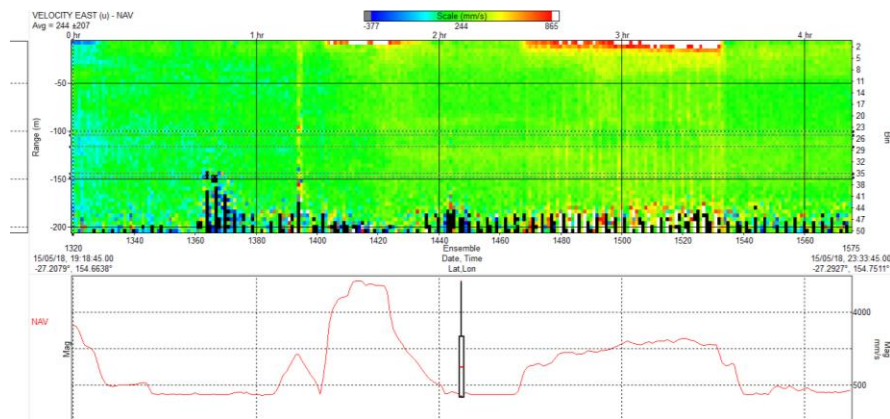
Figure 4 – Bubble effect only there during steaming.

On reading the manual and the UH Report by Jules Hammon on the RV Sikuliaq installation, we determined that it was likely due to bubbles flowing past the transducer head.

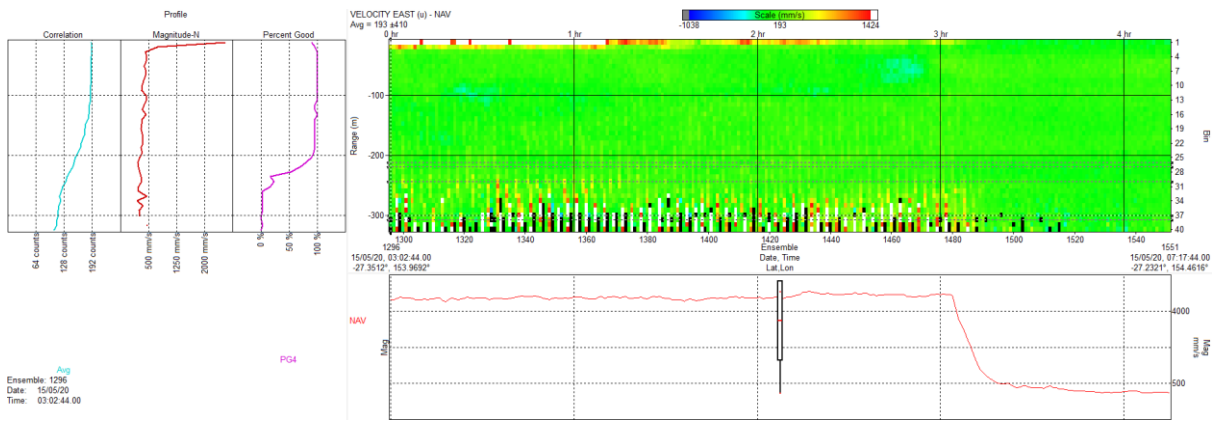
**Figure 5 – ADCP magnitude for 20th-May for 0720 to 1125. Drop keel was lowered 4 m at 0716. The effect is still there but weaker.**

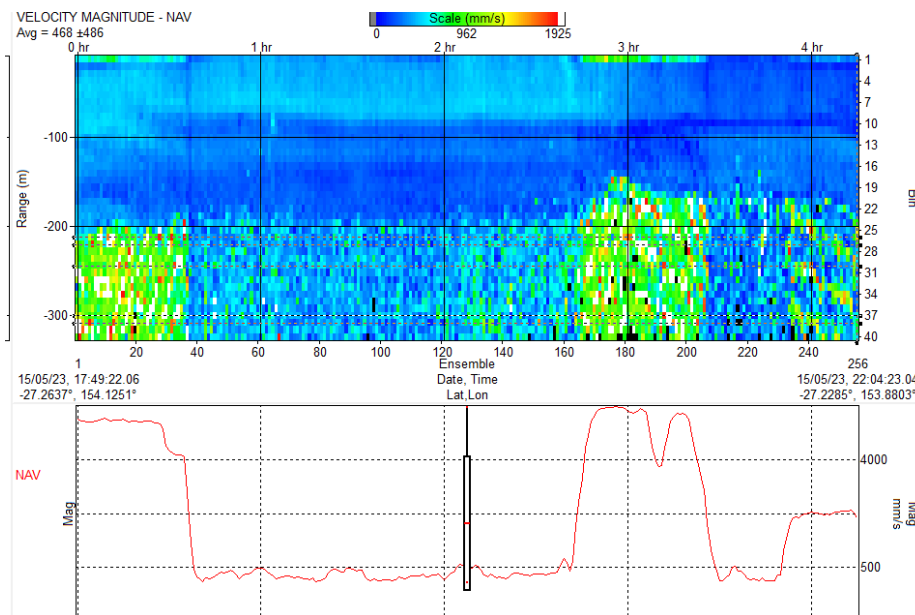
**Figure 6 – example of OS150 BB output with dropkeep at 2m – bubble effect is weakened but is still there. Note the large drop in range due to switching to BB from NB. In2015\_v020100**

In summary, we found that in NB mode, the unrealistic shear affects less bins and that lowering the drop keep helps as well. We did not see any obvious difference between a 2m and 4m extension. We could not eliminate the bubble effect during steaming altogether. It will have to be edited out. This does lessen the value of the OS150, as its main advantage over the OS75 is a smaller blanking distance and resolution near the surface.

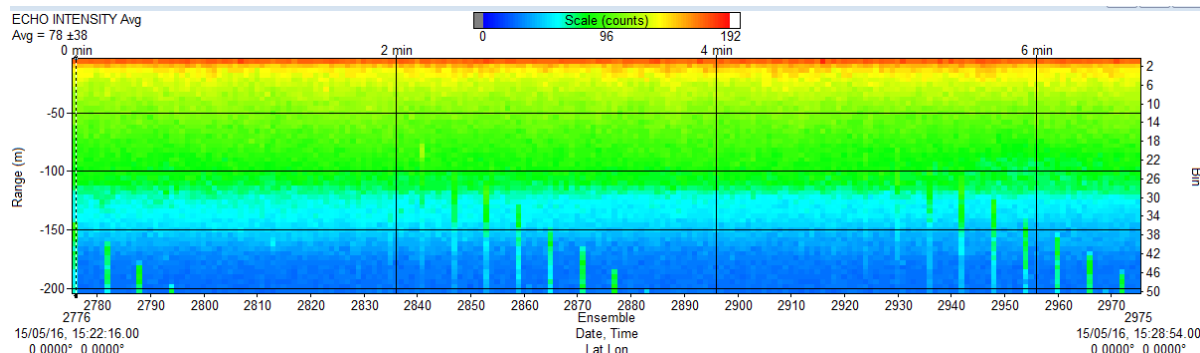
Figure 1: Interference identified in the 150 kHz ADCP files.

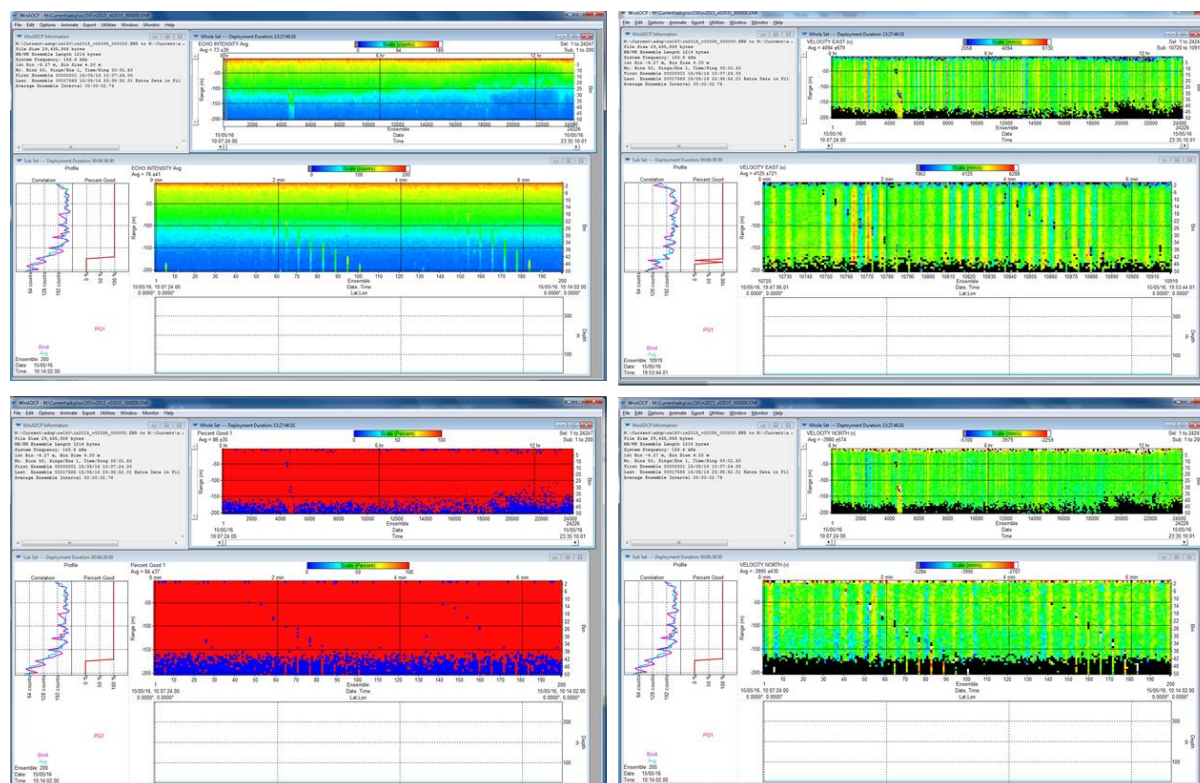
Figure 2: Snapshots from file 2015\_v02035\_000001.ENR; a) Beam Average Echo, showing the recurrent interference; b) Zonal component of velocity, without processing; c) Beam 1 Percent Good; and d) Meridional component of velocity, without processing.

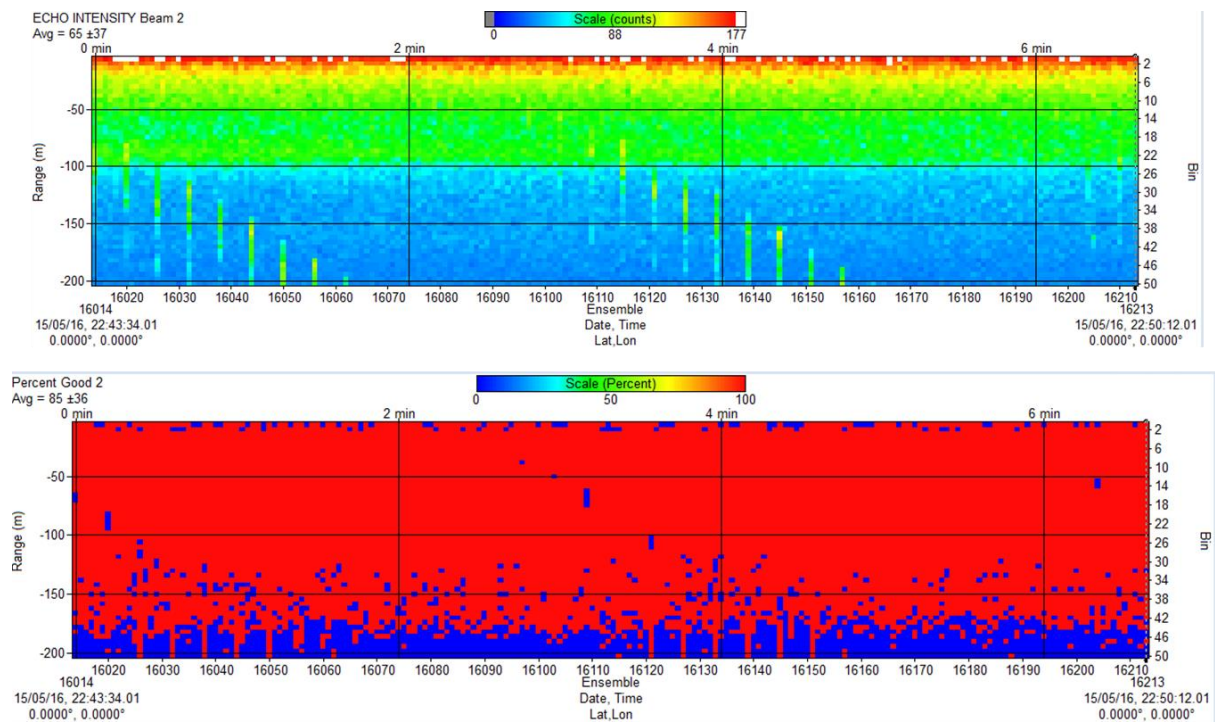
Figure 3: a) Echo intensity from Beam 2 and b) its respective percent good.

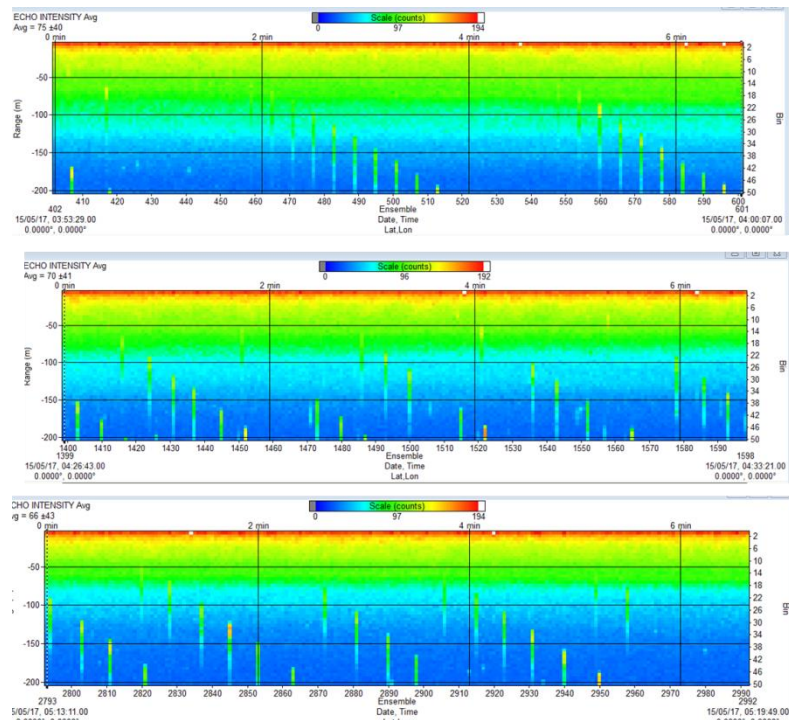
Figure 4: Changes in interference patten in file in2015\_v02036\_000000.ENR.

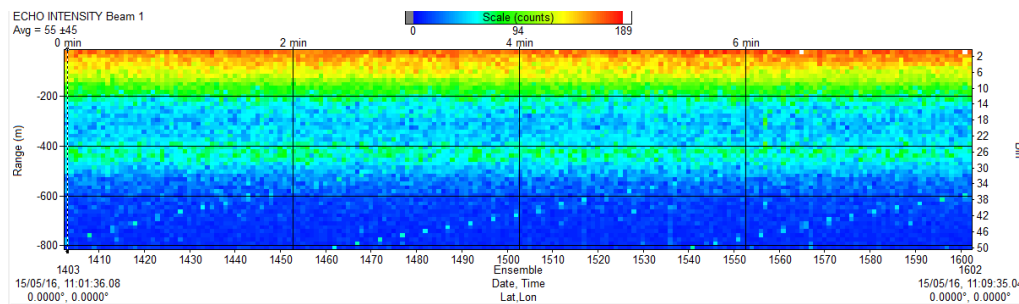
Figure 8: Snapshot in2015\_v02059\_000000.ENR – deep waters.

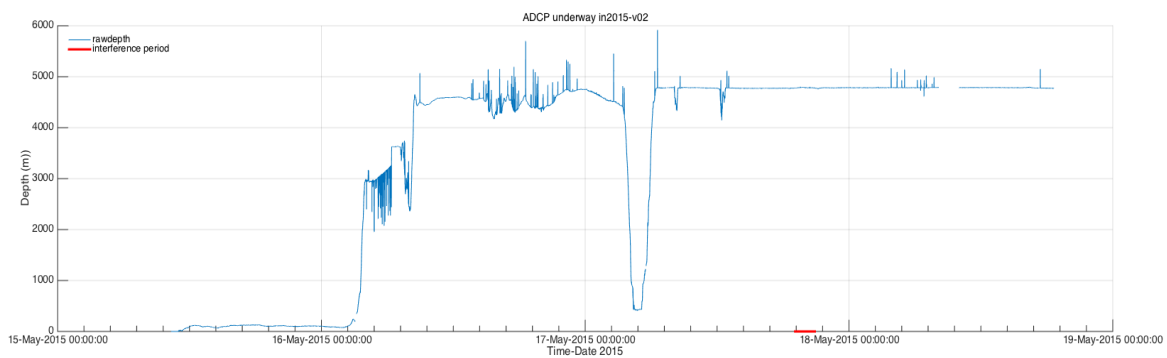
Using Gabi's notes we looked to see if the ships depth sounder was turned off during the period when the interference disappeared. Nina showed that it has been on continuously so we can rule that out as the source of interference.

Figure 9: ships' sounder outputs showing it was on when the OS150 showed interference. The EK60 was turned off early in the voyage.

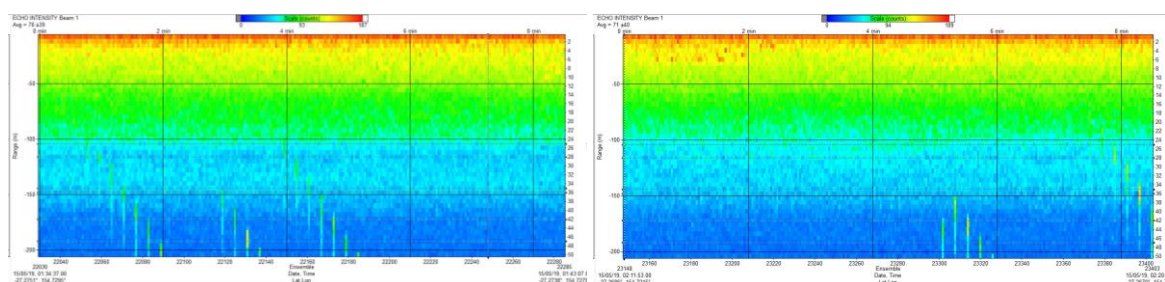
OS75 turned off at ~ 0139 UTC and turned back on at ~ 0217 UTC. Plotting beam EAs in winADCP (see below) showed clearly that the interference pattern disappeared when the OS75 was turned off and reappeared on its start up. This means that in the OS150, it is the OS75 that is causing interference. [file = M:\Current\adcp\os150\in2015\_v02038\_000006.ENX]

**Summary:** As documented in the RDI manual and noted in the UH Report by Jules Hammon on the *RV Sikuliaq* installation, the OS75 and OS150 interfere with each other. The UH expert group suggest that this is OK as the affected bins can be edited out ping by ping in CODAS. It does mean that the .STA and .LTA ensemble averages output by VmDAS are biased by this interference (use – beware). UH recommend letting the two OS ping as fast as possible and to avoid syncing them as this drastically reduces the number of water pings, and thus drives up the random error in the ensemble averages.

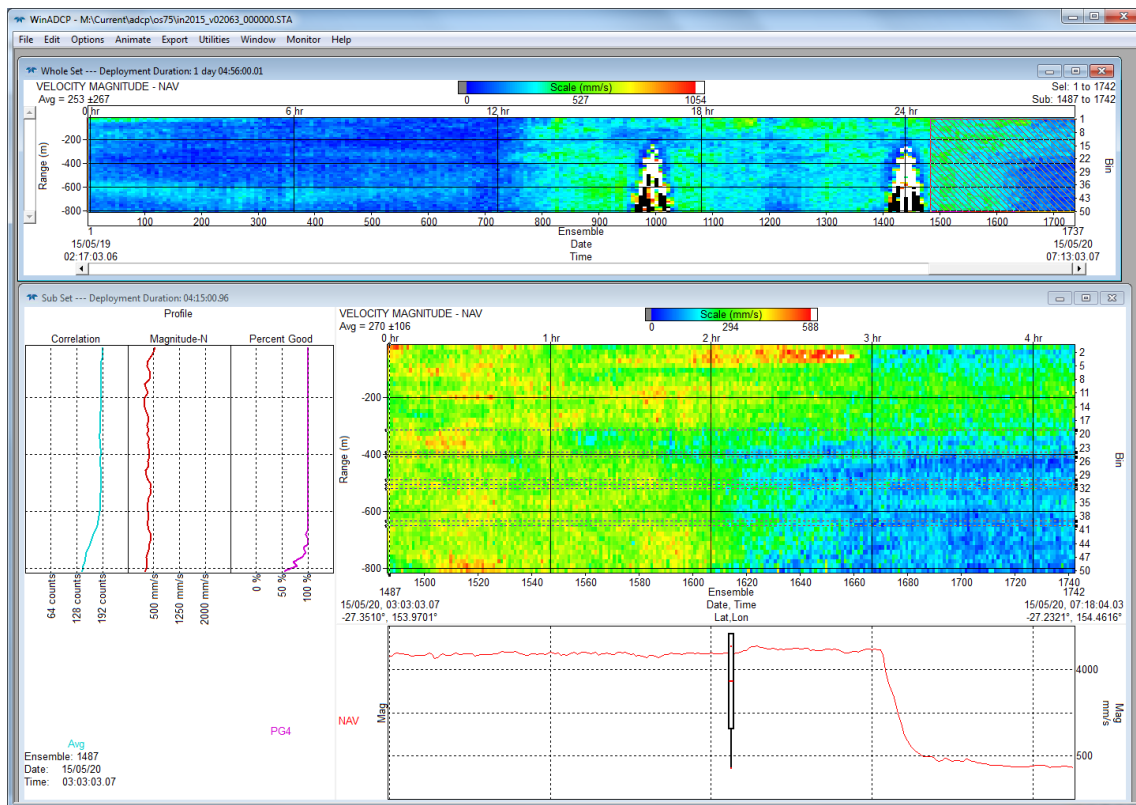
Above has drop keel flush with the gondola.

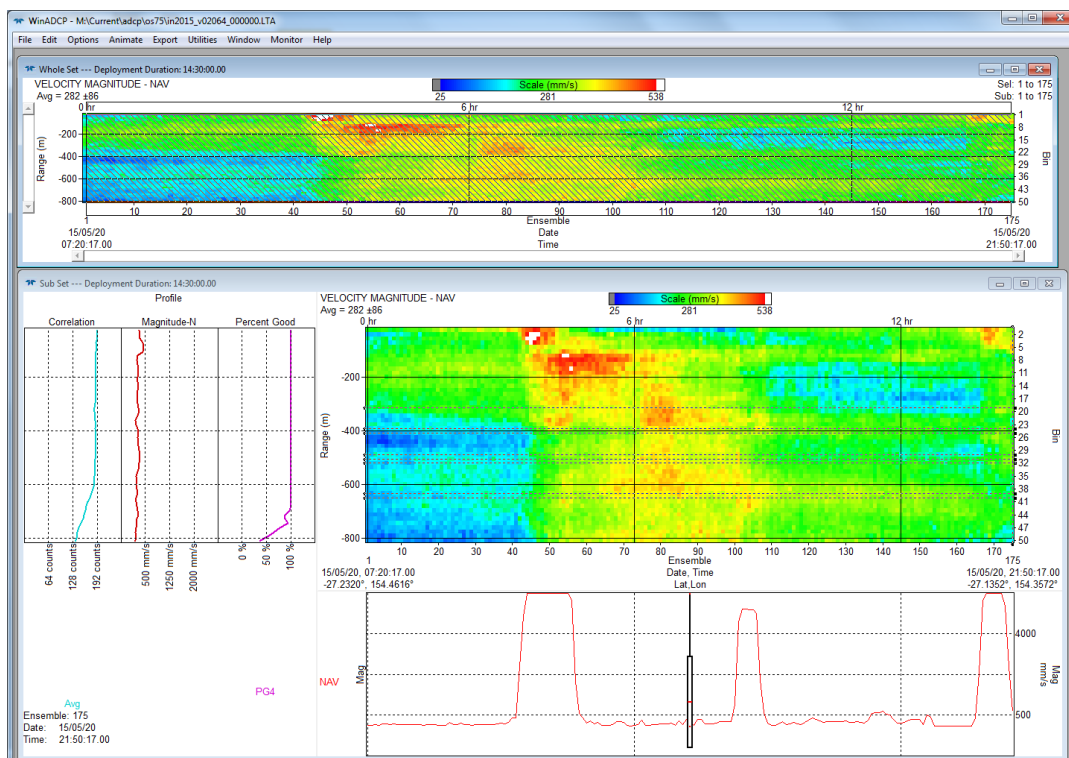
Above is with the drop keep fully extended.

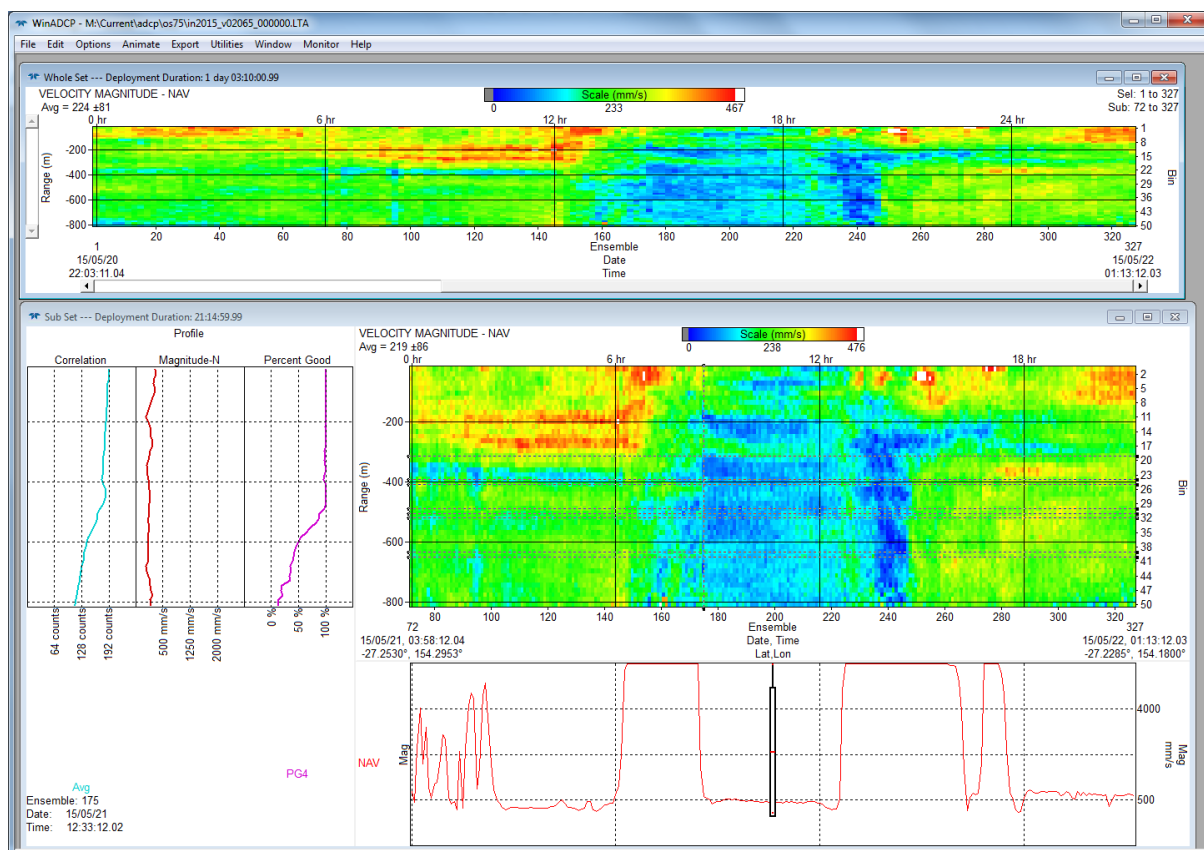
Above is where the drop keel is half extended.

There appears to be no degradation of the OS75 by having the drop keel extended but this effect could be further check in post processing using CODAS.
