IN2015\_V02  
ADCP trials and trouble shooting  
May 2015

Susan Wijffels

Summary

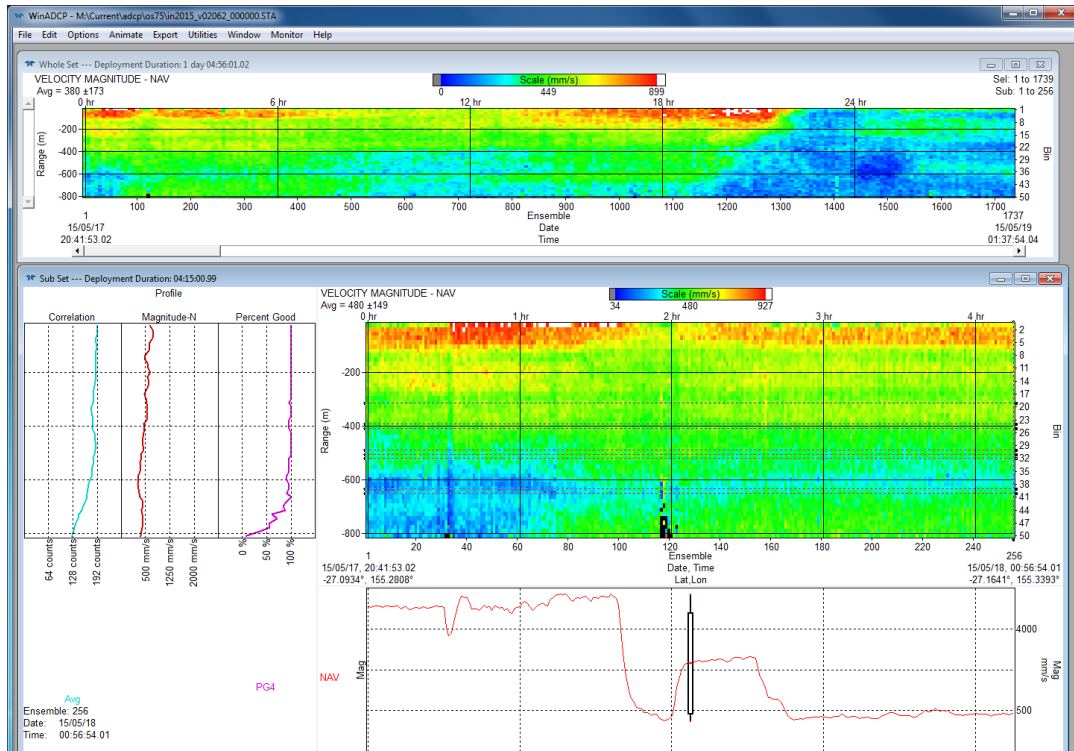
Drop keel was moved to full extension (4m below gondola) at 0717 20/05 UTC

Drop keel was moved to medium position (2m below gondola) at 2203 20/05/2015

Above has drop keel flush with the gondola.
