R.V. FRANKLIN

NATIONAL FACILITY OCEANOGRAPHIC RESEARCH VESSEL

RESEARCH SUMMARY

CRUISE FR 1/90

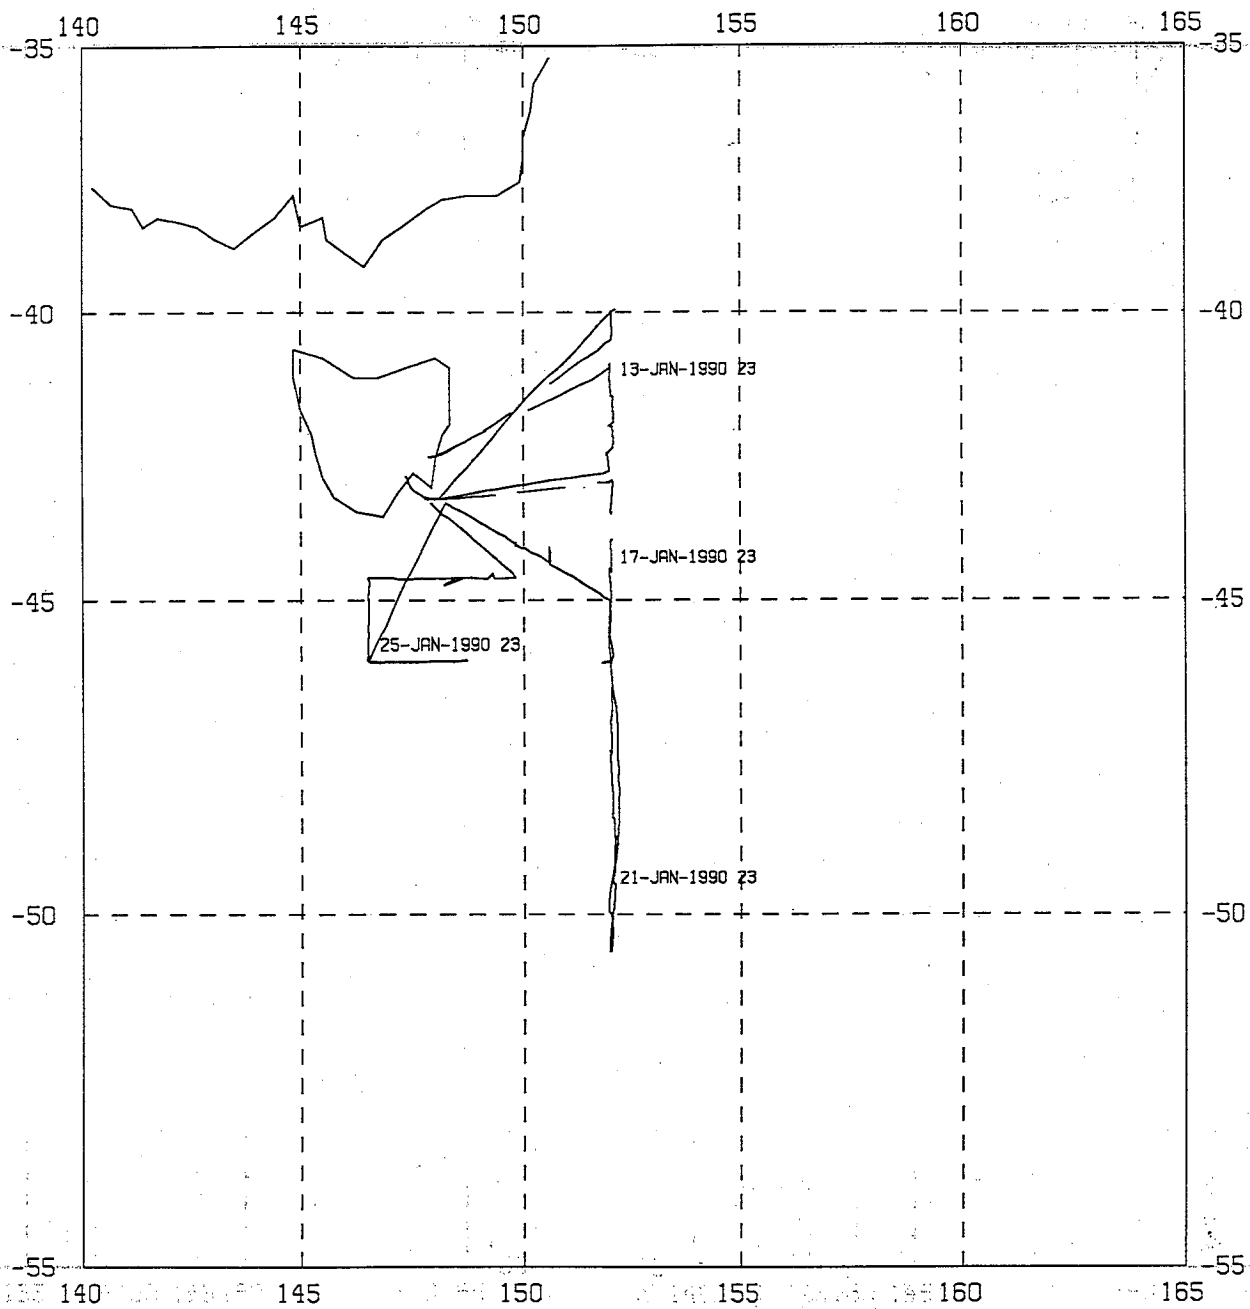
Figure 1

FR 01/90 10-30 JAN 90
