# **RV** *Investigator* Voyage Scientific Highlights and Summary

Voyage #:	IN2019_V07			
Voyage title:	RAN Hydrographic and Maritime Heritage Surveys			
Mobilisation:	Hobart, Wednesday, 10 April 2019			
Depart:	Hobart, 0800 Thursday, 11 April 2019			
Return:	Hobart, 0800 Tuesday, 23 A	April 2019		
Demobilisation:	Hobart, Tuesday, 23 April 2	:019		
Voyage Manager:	Max McGuire	Contact details:	Max.Mcguire@csiro.au +61 477 397 439	
Chief Scientist:	Emily Jateff			
Affiliation:	Australian National Maritime Museum	Contact details:	emily.jateff@sea.museum +61 448 588 374	
Principal Investigators:	Emily Jateff (ANMM)			
Project name:	Maritime Heritage Surveys			
Affiliation:	Australian National Maritime Museum	Contact details:	emily.jateff@sea.museum +61 448 588 374	
Principal Investigator:	Australian Hydrographic Office (AHO)			
Project name:	RAN Hydrographic Survey (SI003)			
Affiliation:	Australian Hydrographic OfficeContact details:hydro.plans@defence.gov.au			
Principal Investigator:	Eric Woehler

RAN Hydrographic and Maritime Heritage Surveys

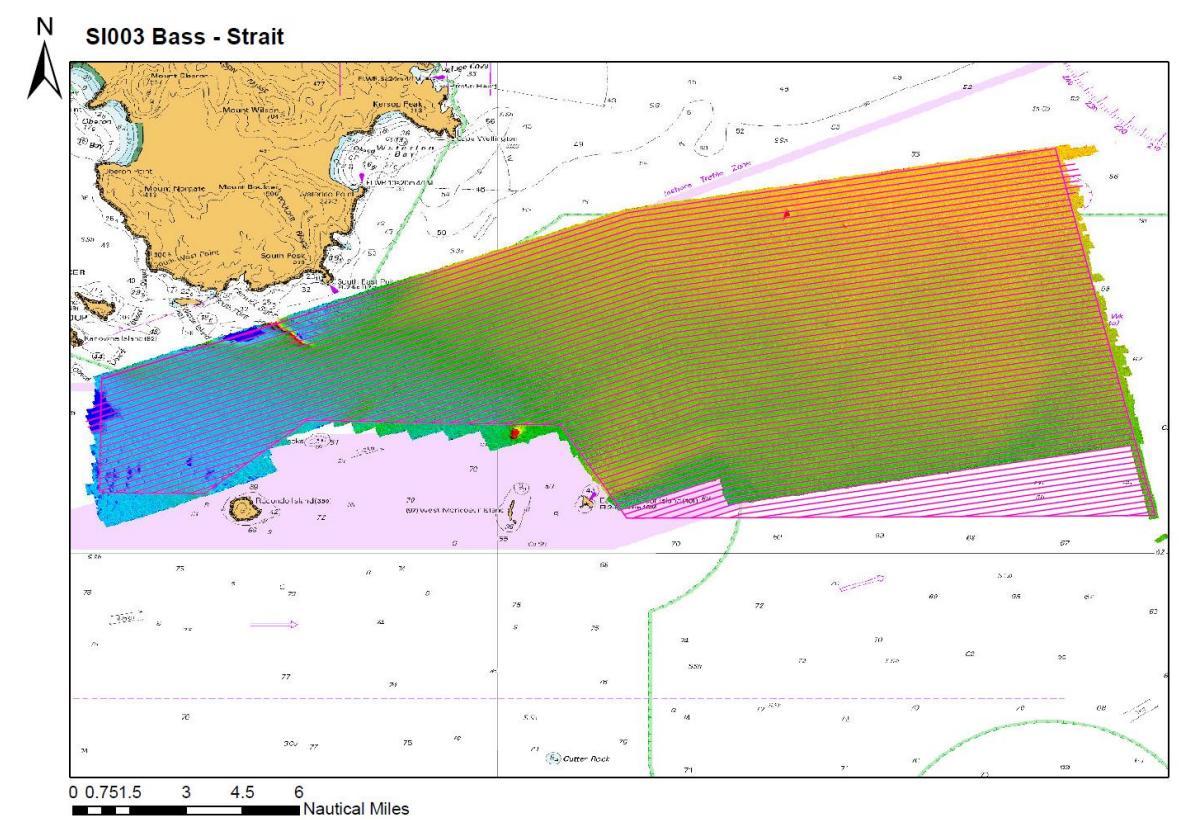
Figure 1: AHO Survey Area A. The hollow section contained within the pink polygon (in the SE corner) is the section to be mapped during IN2019 V07 (SI003).

- Completion of mapping of Sub Area A within Bass Strait (outstanding from IN2018\_C01): ~24 hours using EM710.
- The survey was conducted according to the GSM Hydrographic Survey Procedure (included as Appendix C with the Voyage Plan) for the original survey. This procedure is current for the

- The Kongsberg EM710-MK2 Multibeam Echosounder (MBES) will be used to complete the survey, instead of the Kongsberg EM2040c (Dual Head) Multibeam Echosounder (MBES) used for the original survey during IN2018\_C01.
- The survey area differs in that it includes only the portion of Sub Area A which was left incomplete during the IN2018\_C01 voyage (see Figure 1). As such, timings will vary from the original procedure.
- Sediment sampling using the Smith Mac grab will not occur during this survey.
- The Survey Instruction (SI003) is as Appendix D with the Voyage Plan.

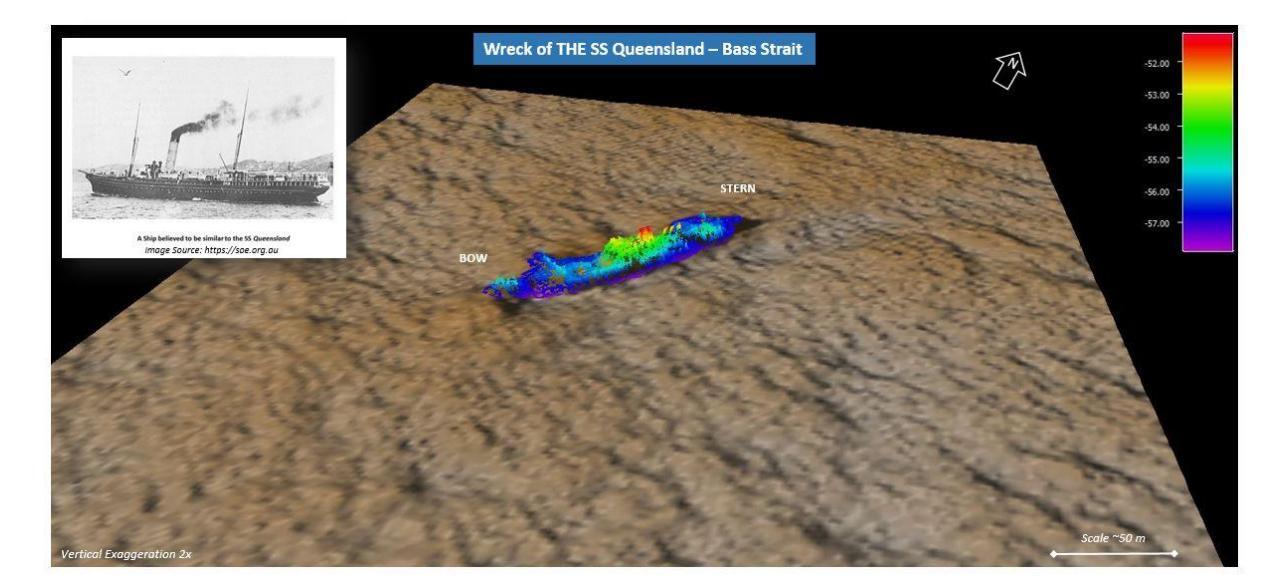
Figure 2: MBES image of SS *Queensland*, as surveyed on 13 April 2019, by Craig Davey and Phil van den Bossche, GSM team on board RV *Investigator*. Courtesy CSIRO/Marine National Facility.

Investigation of MBES and drop camera footage recovered from the site of SS *Queensland* demonstrate no significant difference in site composition from the site plan drawn in 2010. Two masts, engine and anchor sighted on drop camera footage and collapsed hull structure were noted to be in a similar position as seen in 2010. As footage was collected in a single line from E-W, not enough data was collected to determine if loose objects have been removed from the site at this time.

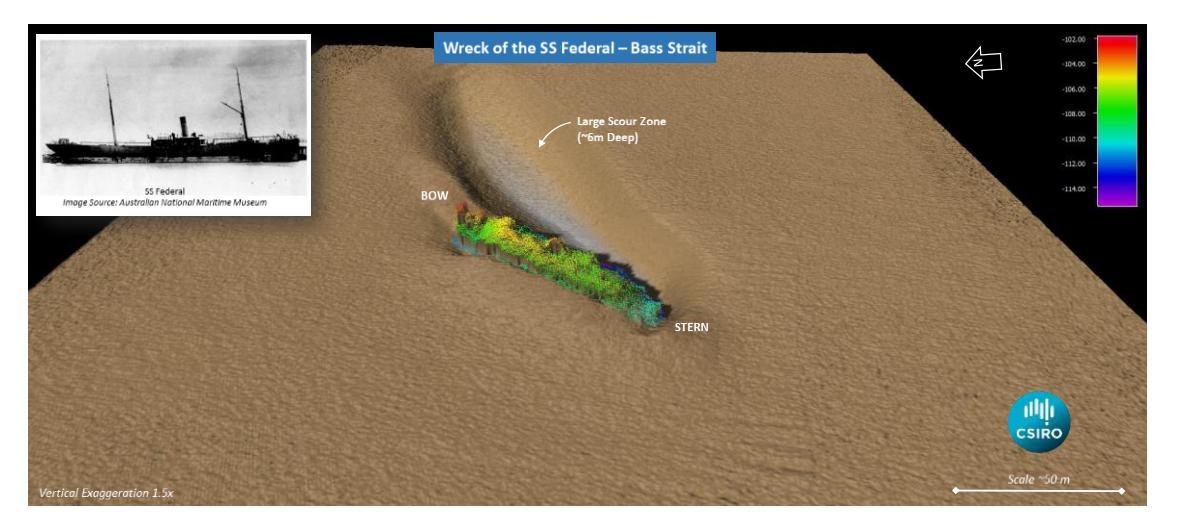
Figure 3: MBES image of SS *Federal* as surveyed on 15 April 2019, by Craig Davey and Phil van den Bossche, GSM team on board RV *Investigator*. Courtesy CSIRO/Marine National Facility.

The SS *Federal* is sitting at an angle perched on top of a 6 m deep scour (vessel is located in tidal flow within Bass Strait). The site is quite broken up, with the stern smashed, although bow not sighted, hull plate on starboard side beginning to fall into scour. Drop camera and GoPro footage collected from the site will be used to identify if there has been any noticeable change in the overall composition of the site since it was first imaged in 2012.

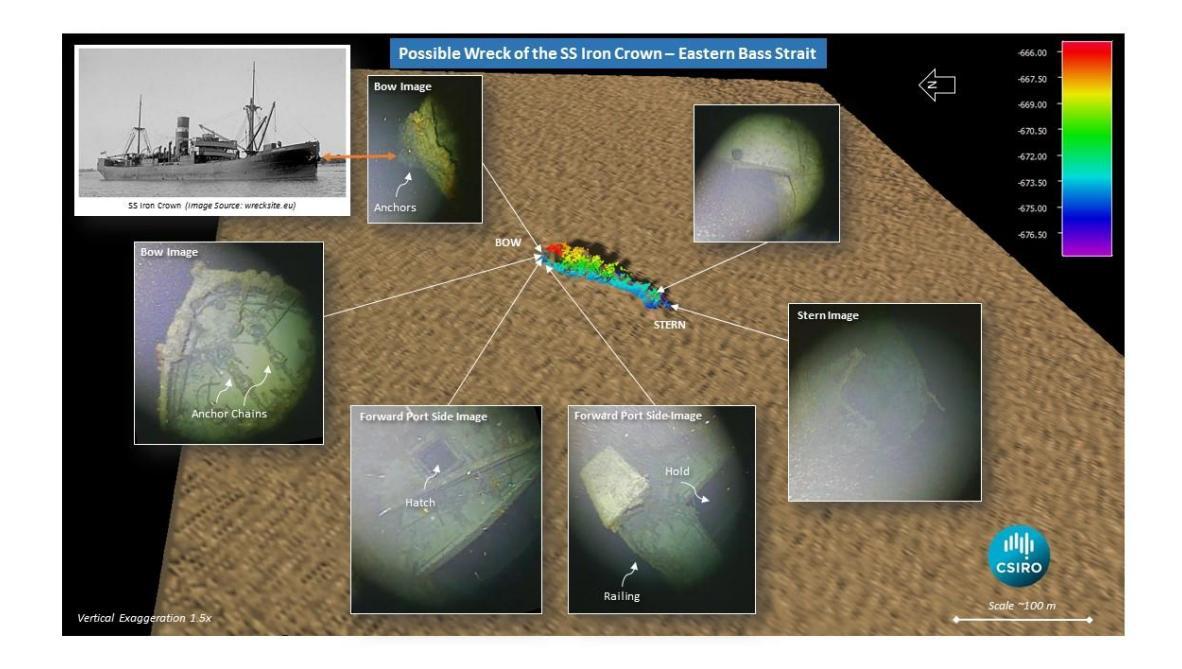
Figure 4: MBES image of SS *Iron Crown* as surveyed on 16 April 2019, by Craig Davey and Phil van den Bossche, GSM team on board RV *Investigator*. Courtesy CSIRO/Marine National Facility.

The SS *Iron Crown* sank quickly—with one account stating within five minutes—and as such, some sections of the vessel, such as the bow, retain a striking amount of structural integrity, with some more significant damage noted to the superstructure at midships. Time constraints limited our collection of drop camera footage at the site and we were unable to recover any imagery from the stern section of the vessel. Identification of the SS *Iron Crown* is significant as an important World War II era shipwreck site in Victorian waters. Data recovered from the SS *Iron Crown* survey will assist in reconstructing the wrecking event and provide a measure of closure to the descendants whose relatives lost their lives in the attack.

A possible feature was noted at 1600 m depth about 5 min in to the start of TR IC11. The feature measured about 100 m in length with an approximate beam of 16-22 m and profile of 8 m. TR IC12: Return (45 min)—intent to ping again the feature noted on TR IC11. Feature sighted again but at the same level as ambient noise, so was very difficult to refine. Ran ship north at a 30 degree angle from start of Transect IC12 perpendicular and across the feature located on TR IC11. The feature was still visible, however noise was still present, so the ship then ran south at a 30 degree angle perpendicular to site. Still present: location at 667-675 metres of water. We determined that further refining of the site is impossible at depth and made the decision to deploy the drop camera at 0200 at the midships point of the site which resulted in immediate positive identification of a shipwreck site.

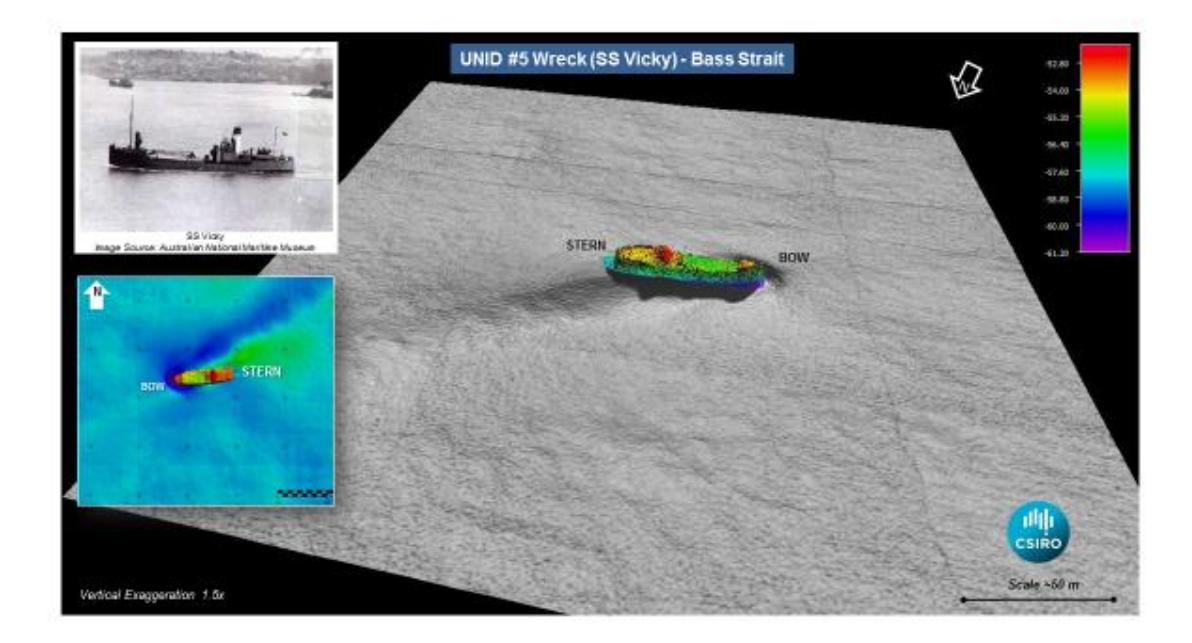
Figure 5: MBES image of SS *Vicky* as surveyed on 17 April 2019, by Craig Davey and Phil van den Bossche, GSM team on board RV *Investigator*. Courtesy CSIRO/Marine National Facility.

In addition to the location of SS *Federal* and SS *Iron Crown*, we conducted surveys to locate, identify and image a series of high priority shipwreck sites in Victorian waters provided as targets identified through aerial magnetometry. Extensive survey within these areas (UID 2-6) did not locate any new shipwreck sites, although extensive mapping and limited drop camera imagery of the shipwreck site SS *Vicky* were acquired for management purposes.

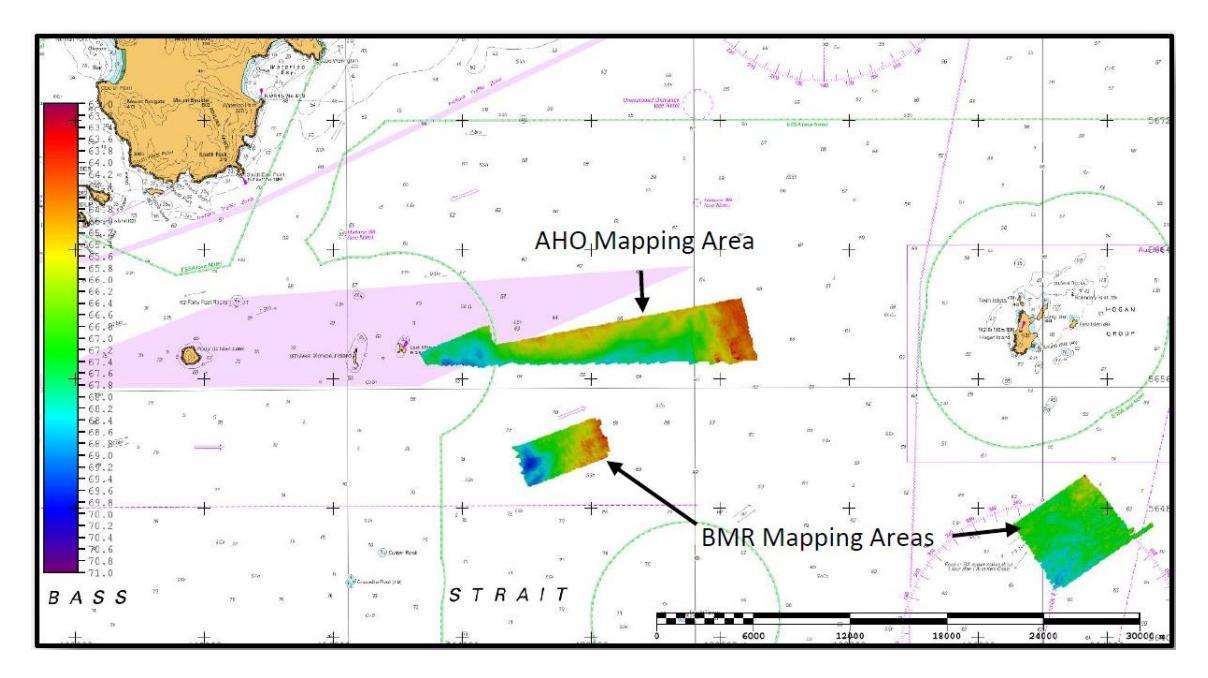
Figure 6: AHO and Beagle Marine Park mapping areas completed during IN2019\_V07.

The outstanding survey area (a portion of Area A) was completed during this voyage, using the EM710 (see Figure 6). During the survey, all other sounders were switched off and the EM710 was triggered internally to increase the ping rate for a greater sounding density. Throughout the duration of the survey, sound velocity profiles were performed, using the Valeport Monitor SVP at regular intervals (~6-8 hours). This represents the first survey of this area using modern equipment and further improves confidence for the safe navigation of international and coastal shipping in Bass Strait.

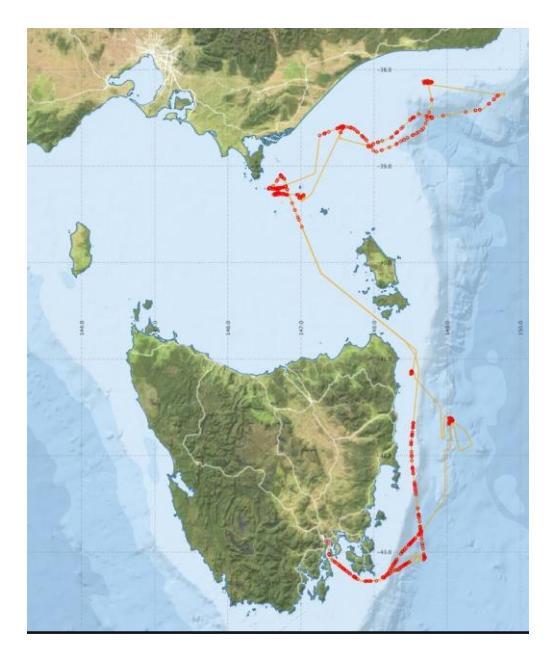
Figure 7: Voyage track with sites of survey observations shown.

Continuous surveys of seabirds and marine mammals were undertaken during daylight hours throughout the voyage. Observations were centred on the southeast of Tasmania and south of Victoria, with the transits between these two areas undertaken at night. Details of observations of marine debris were also recorded.

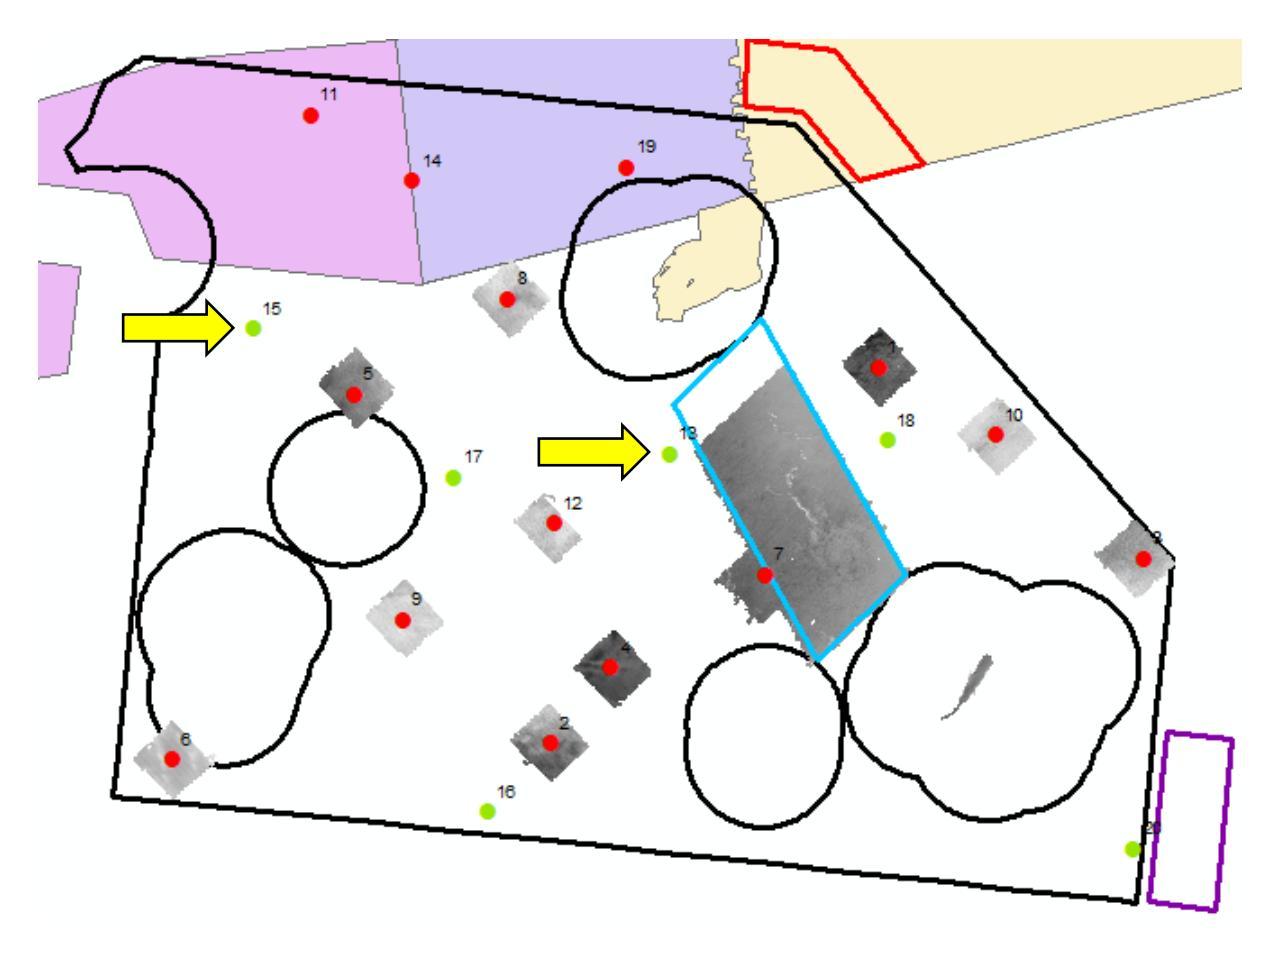
Figure 8: Beagle Marine Park mapping sites (sites 13 and 15 indicated by yellow arrows).

An additional two sampling sites within the Beagle Marine Park were mapped by RV *Investigator* during IN2019\_V07 (see Figure 8). Time became available to complete one 5 x 5 km sampling site (BMR Site 13) and partially complete (~52%) a second 5 x 5 km sampling site (BMR Site 15). Block 13 took 11 hours to map at an interline spacing of 150 m in an average water depth of ~63 m. The mapping of these two sampling sites adds greater statistical confidence to estimates of habitat cover in the area as well as improving knowledge of the physical processes that structure the seabed features of this region. The seabed in the new areas surveyed appears to be predominantly soft sediment/gravel beds, and shows evidence of significant sediment mobility due to the strong currents that move through the eastern entrance to Bass Strait. Future re-mapping of these features will be particularly informative of the time-scale of events that structure the seabed ripple and dune features seen in the bathymetry.

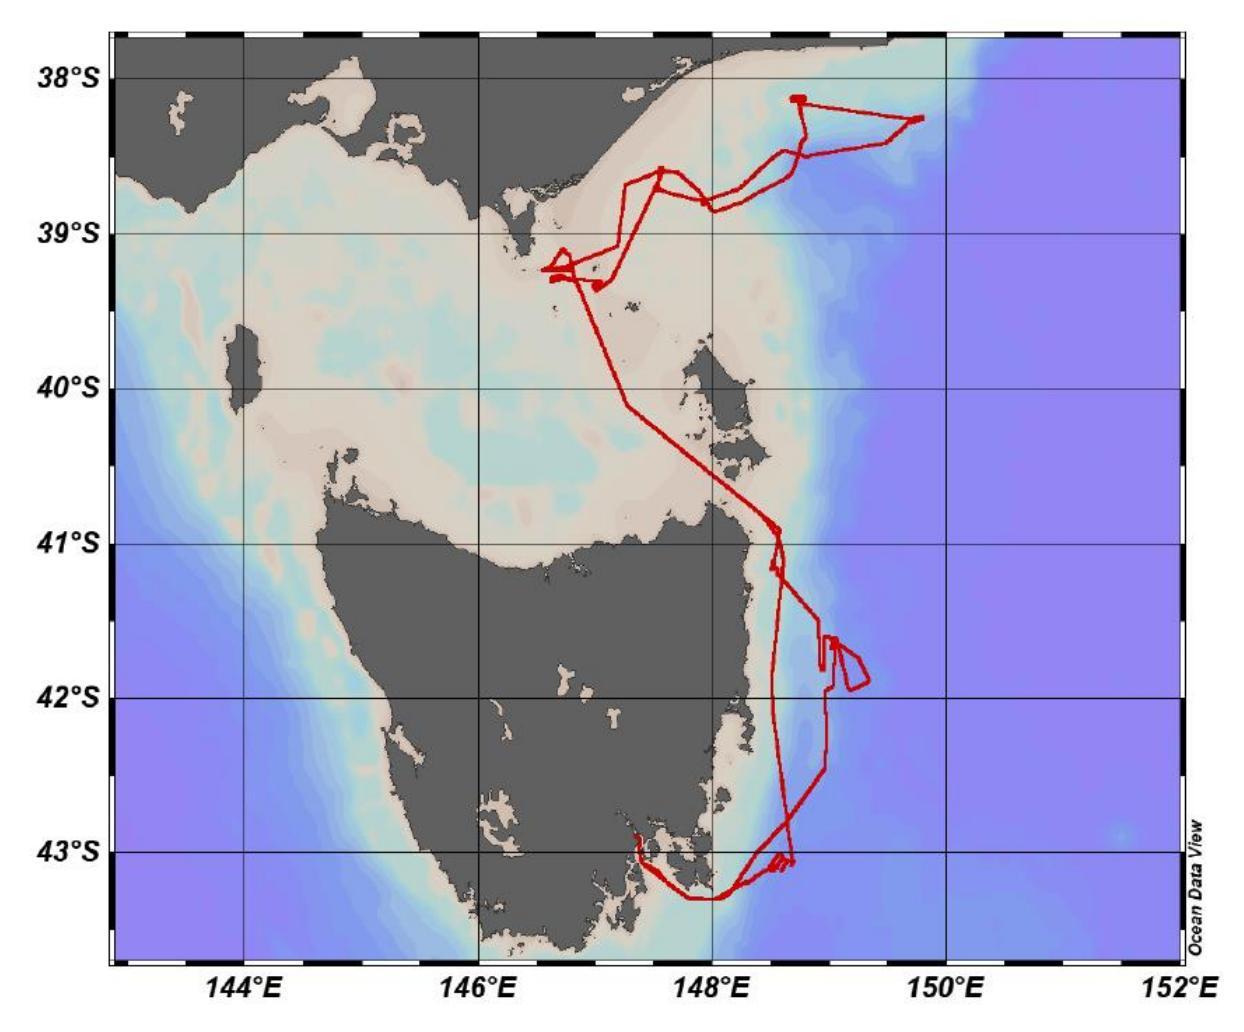
Figure 9: IN2019\_V07 Voyage Track.

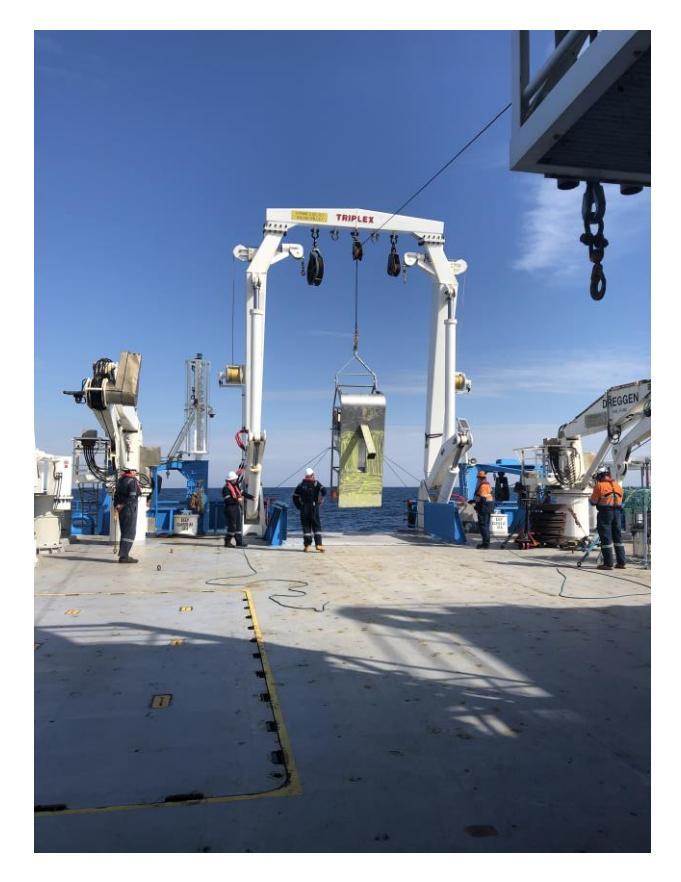
Figure 13: Brenke sled deployment (image credit: Megan Dykman, MNF).

- Trialling of the new Brenke sled system.
- Training of new personnel in the deployment of other equipment, including the multicorer and possibly, the Smith Mac grab.
